FAQ

Issues after RBI connection to AiM CAN network

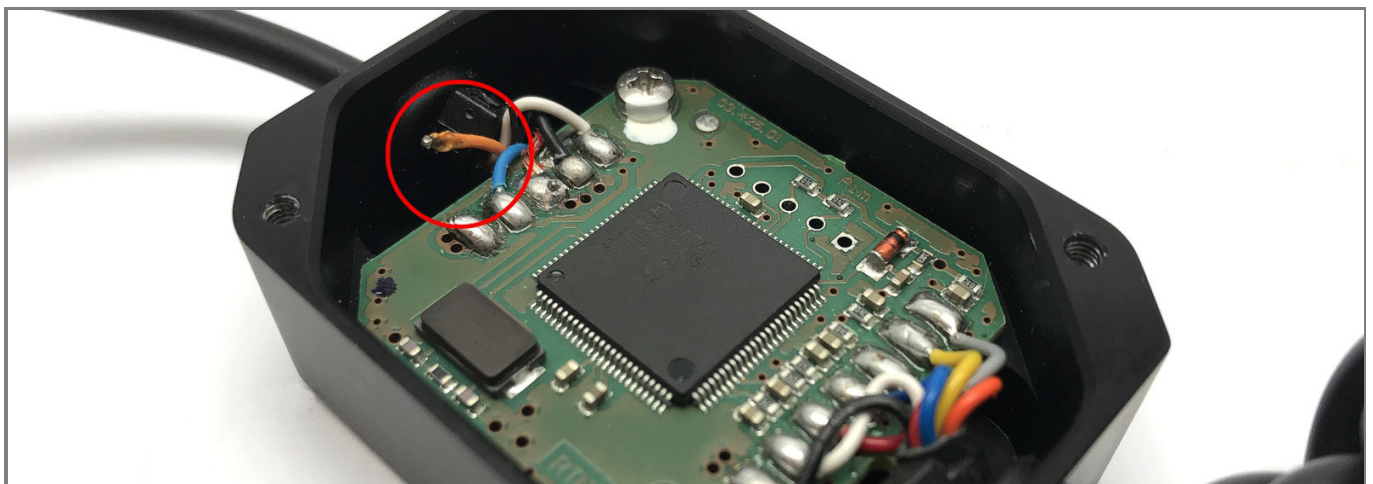
The issue previously occurred when RBI Module was connected to AiM CAN network since it caused a voltage comeback that did not allow the network to switch off, making thus impossible the network reset and the following identification process.

If your RBI Module serial number is lower than 4600373 you can fix the problem with an hardware modification of RBI following these steps:

- unscrew the RBI top cover and remove it
- this way you have access to the internal board that shows wires weld on both sides: wires that go to the 5 pins male Binder connector and free wires you can connect to the buttons
- among the wires going to the Binder connector cut the orange one (Vbext – this is the one that causes the voltage comeback) paying attention that it does not come in contact with the welding places (image below).
- replace the top cover, screw it and reconnect RBI to the AiM CAN network.
