FAQ

MXL2, MXG and MXS power noise related to the “crank”

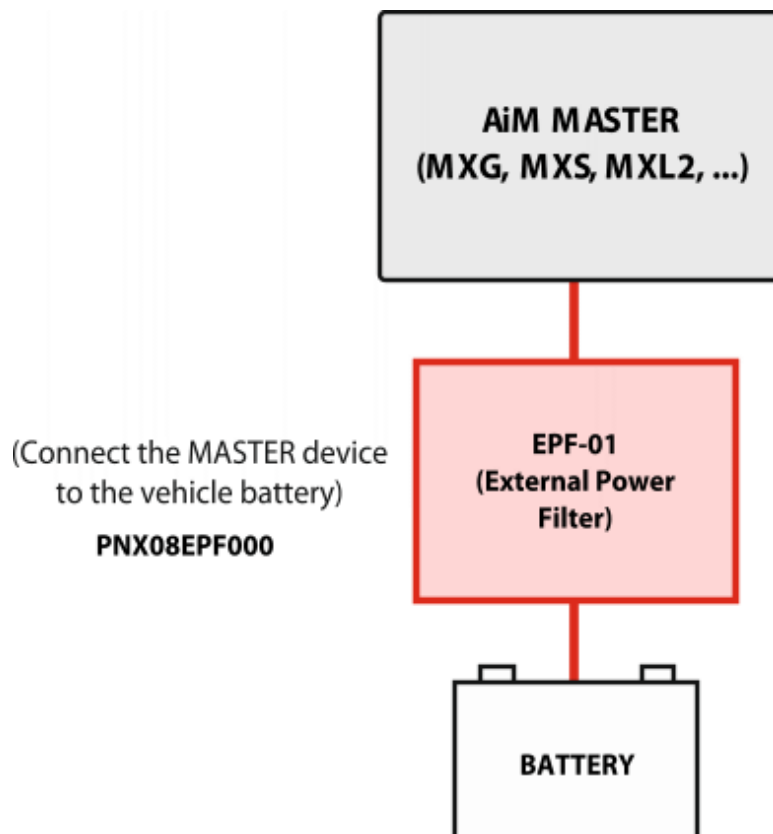
Dash locks at the “crank”.

This problem may appear on the following systems:

- **MXL2:** up to SN 4302188
- **MXS:** up to SN 450087
- **MXG:** up to SN 4201217

Use the external power **filter** EOF-01 part number: **X08EPF000**
